**EVALUATION OF MECHANICAL PROPERTIES,
OXIDATION RESISTANCE, AND STRUCTURE OF
SLURRY SILICIDE COATED T-222**

by
A. M. FILIPPI

Westinghouse Astronuclear Laboratory

**NATIONAL AERONAUTICS AND SPACE ADMINISTRATION
NASA Lewis Research Center
Contract NAS 3-12410**

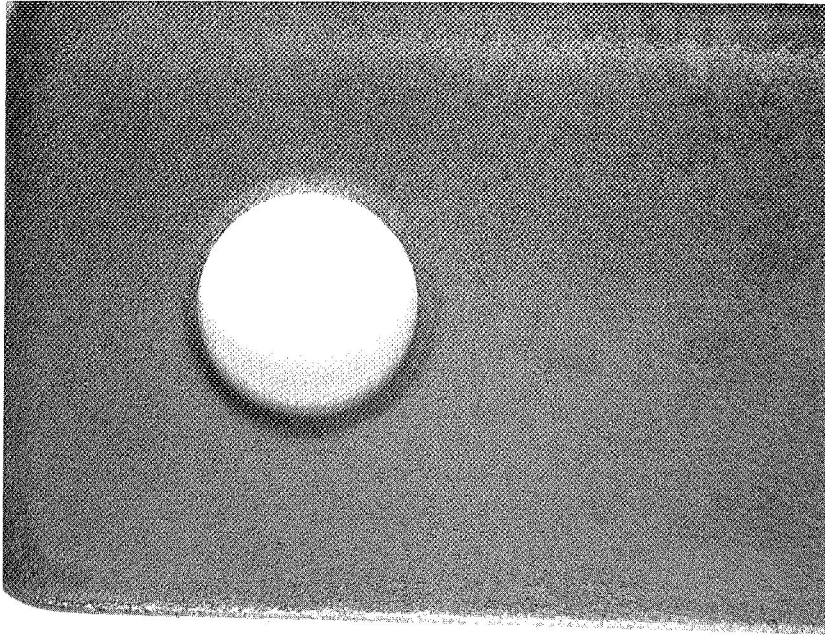
(A)

Oxidation testing at 2400° F was approached cautiously due to an anticipated problem of sample handling, and only one sample, arbitrarily chosen to be tensile 28, was used in an initial two hour test. Unaided visual inspection of this sample after 2 hour exposure at 2400° F revealed a coating crack located approximately 1/2 inch below a pin hole. Oxidation of the substrate at the defective site, however, was not evident.

A photograph showing the crack is presented in Figure 7A. As a consequence of this, close examination was made of the coating on the other samples scheduled for oxidation revealing, with assistance of 5X magnification, fine hairline cracks on tensile samples 29, 30 and 31, at a location similar to that observed cracked on tensile 28. Photographs of two of these samples displaying the defects are presented in Figure 8. Three tensile samples, numbers 12, 13 and 33, inspected and found to be free of any macroscopically obvious coating cracks, were substituted for specimens 29, 30 and 31. Oxidation was continued, however, on tensile 28. Sample handling did not pose any problem on the initial two hour test using tensile 28, and subsequent tests were performed simultaneously on all samples.

FIGURE 7 - Progress of Coating Failure on Tensile Sample 28

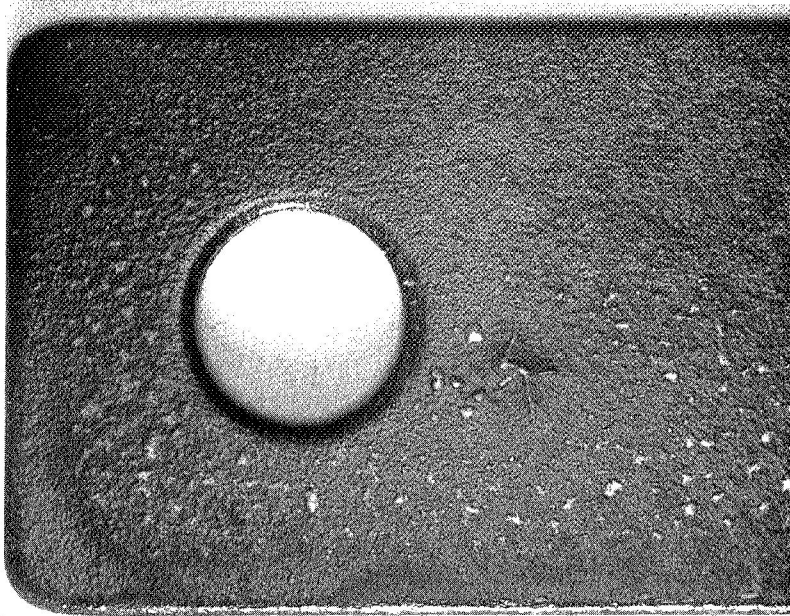
(C)

FIGURE 7 (Continued) - Progress of Coating Failure on Tensile Sample 28

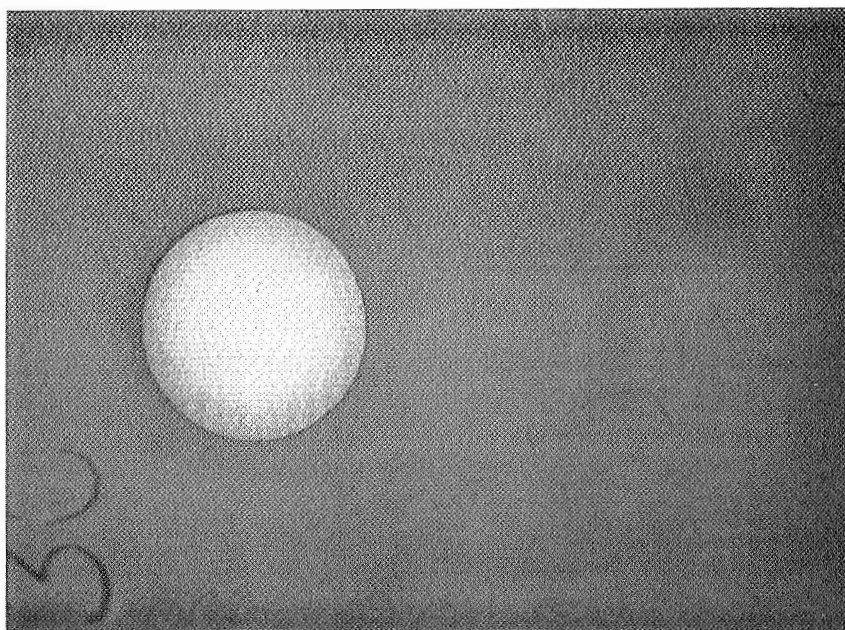
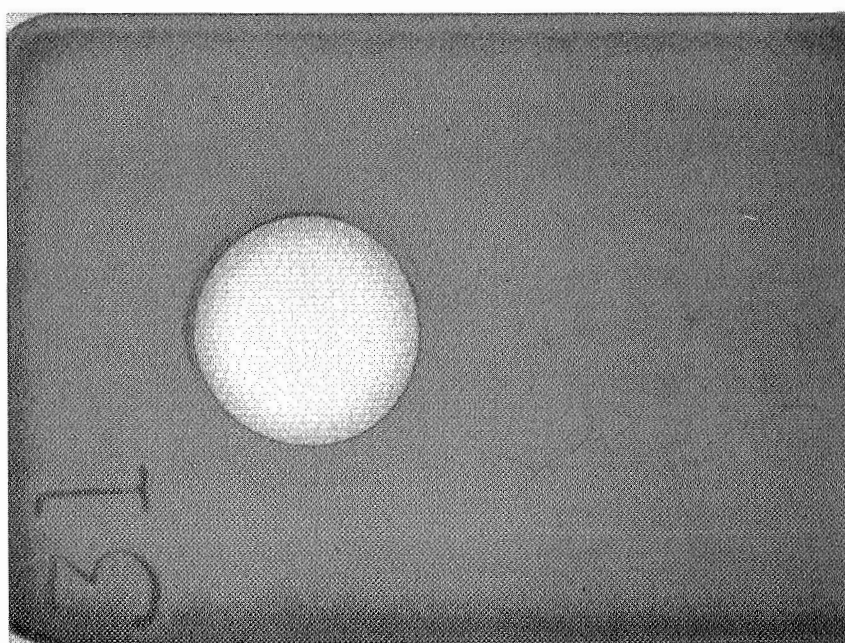
FIGURE 8 - Typical Cracking Found on As-Coated Tensile Samples

above this feature on the other. Because of this, whether the crack found on tensile 28 was present in the as-coated condition or occurred during exposure, cannot be established. Substrate oxidation was not evident at the defective sites on any of these samples, as was observed on tensile 28.

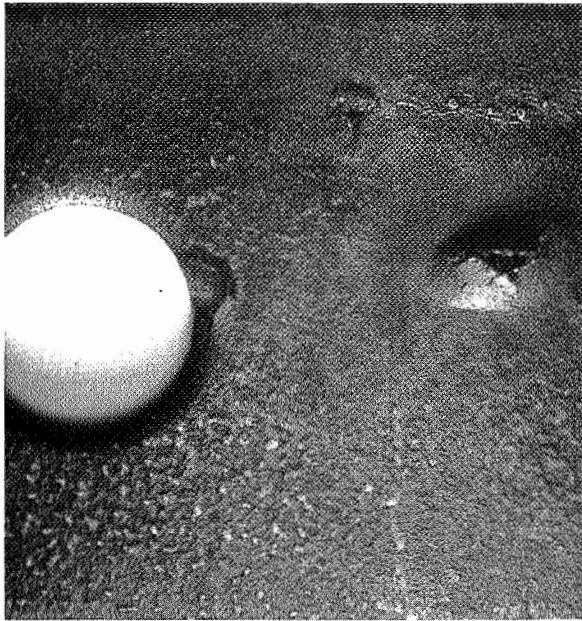
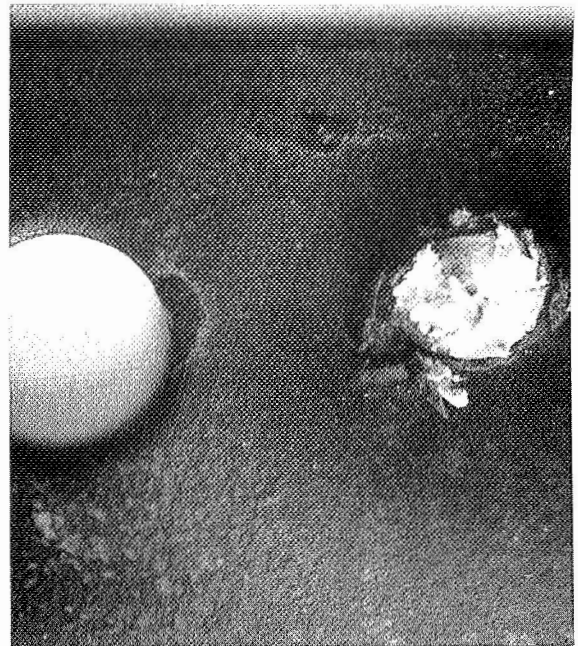
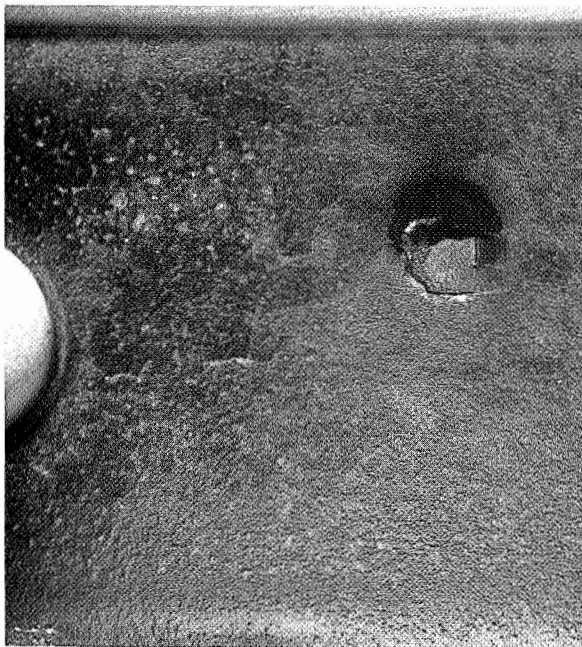
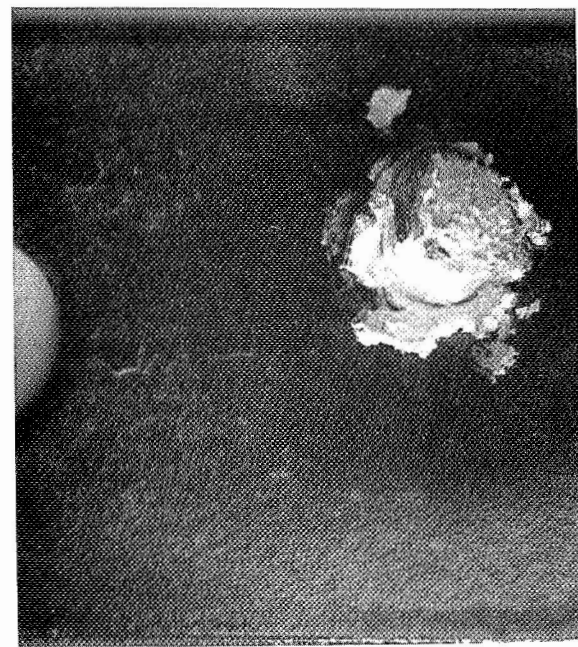
FIGURE 9 - Coating Failure on Tensile Samples 13 and 18
Top: 21 and 24 Hrs. at 2400°F (1589°K); Sample 13
Bottom: 21 and 24 Hrs. at 2400°F; Sample 18

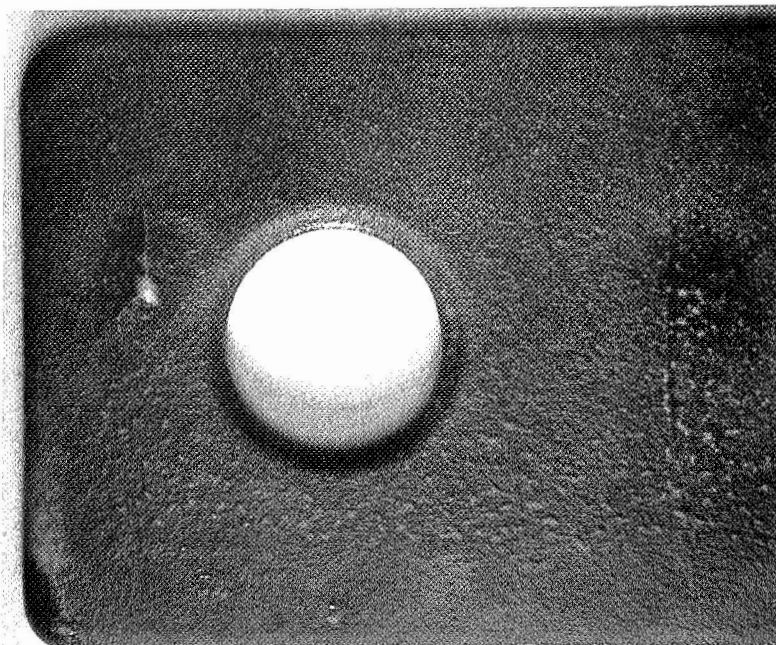
(A)

FIGURE 10 - Progress of Coating Failure on Tensile Sample 12

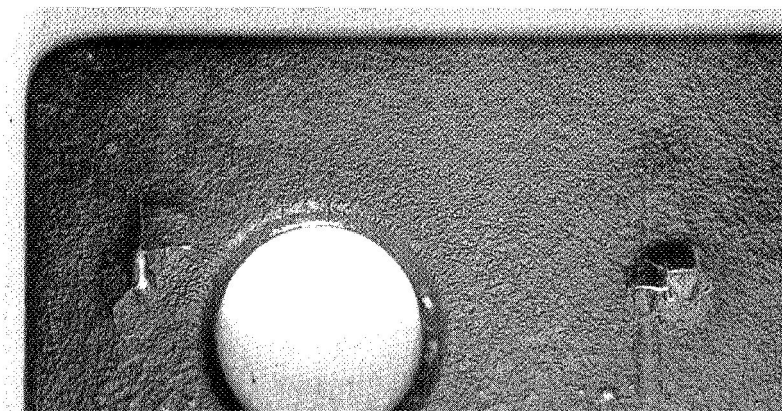
(C)

FIGURE 10 (Continued) - Progress of Coating Failure on Tensile Sample 12

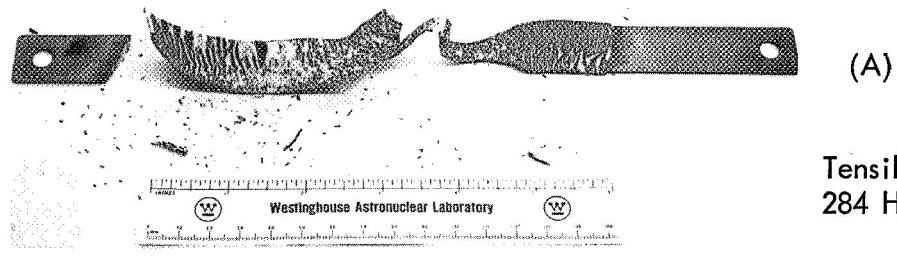
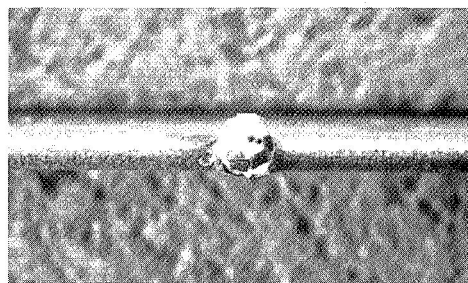
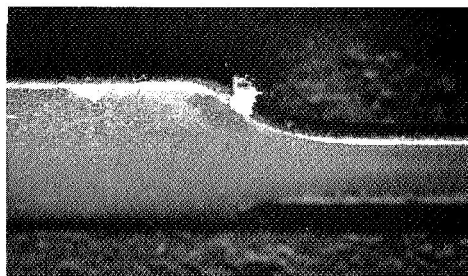
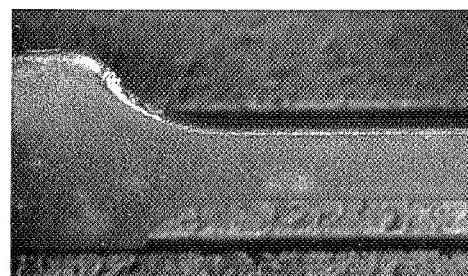
Coating failure on bend 17 could not be attributed to any defect caused by contact with the silicon carbide brick used to hold the specimen, since it occurred on the edge opposite that held in the support slot. In this regard, none of the oxidation failures observed on tensile samples could be related to contact with the SiC brick, since those developed at edge positions were located within a gauge section radius (Nos. 16 and 33), while the four flat surface failures occurred well above the brickline (Nos. 12, 13, 18, 28).

FIGURE 11 - Coating Failure on Tensile Samples 16, 17 and 33, and Bend Sample 17

A possible cause for substrate oxidation on tensiles 16 and 33 might be a thin coating at the failure sites. Both samples developed failures at edge sites within a gauge section radius, at a position close to the corner formed by the head section and the radius — Figures 11C & D. The failures, therefore, occurred on an edge nearly perpendicular to the specimen axis. If the metallic coating constituents applied prior to pack siliciding were sprayed on with the jet kept reasonably perpendicular to the axis of the sample, these regions on each gauge section radius would be least covered, and sites vulnerable to failure. The grip pin holes in the tensile sample would likewise be areas susceptible to application of a thin silicide coat. Coating failure, however, was not experienced within even one pin hole on any tensile sample. Perhaps, because the holes are obviously vulnerable in this respect, greater attention was paid them, to insure they were adequately coated. Whether or not the suggestion offered as a possible explanation for oxidation failure on tensiles 16 and 33 is correct, any edge site, because of its shape, is intuitively a region of high defect probability.

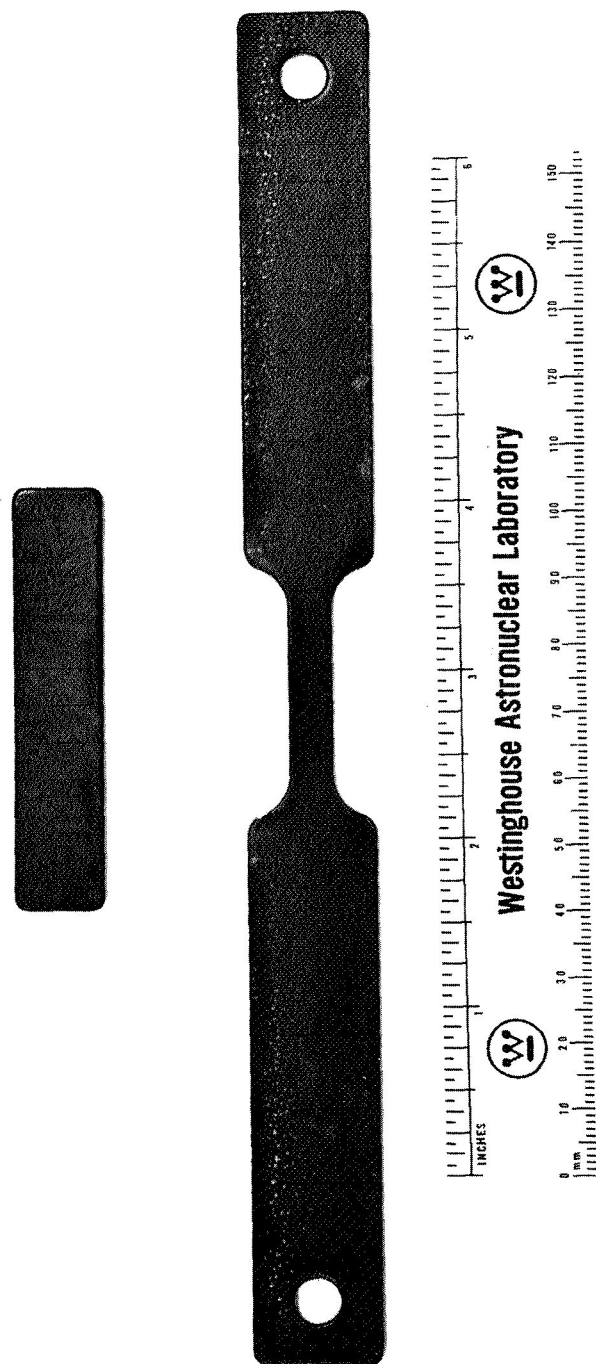
A photograph showing the appearance of a tensile and a bend sample after 304 hours exposure in air at 2400° F is given in Figure 12. A line of slightly raised surface spots is obvious on the head section of the tensile sample, running parallel to its axis and concentrated roughly 3/16" from the edge. Some similar spots can be seen on the bend sample shown in the figure, and in the photographs presented for tensiles 28 and 12 in Figures 7 and 10. These spots developed randomly on the bend samples, and principally near the edge of the tensile samples held in the silicon carbide brick, but above the brickline. Although raised from the surface, the spots visually appeared to be dense, and no association could be found to relate their formation with sites of coating failure.

FIGURE 12 - Sample Appearance After 304 Hours Oxidation at 2400°F (1589°K)

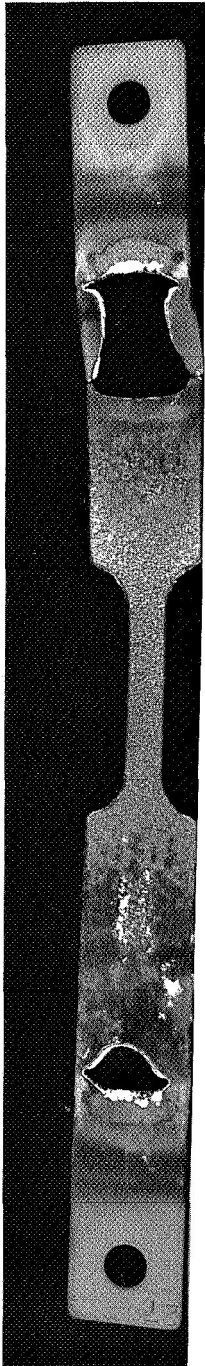
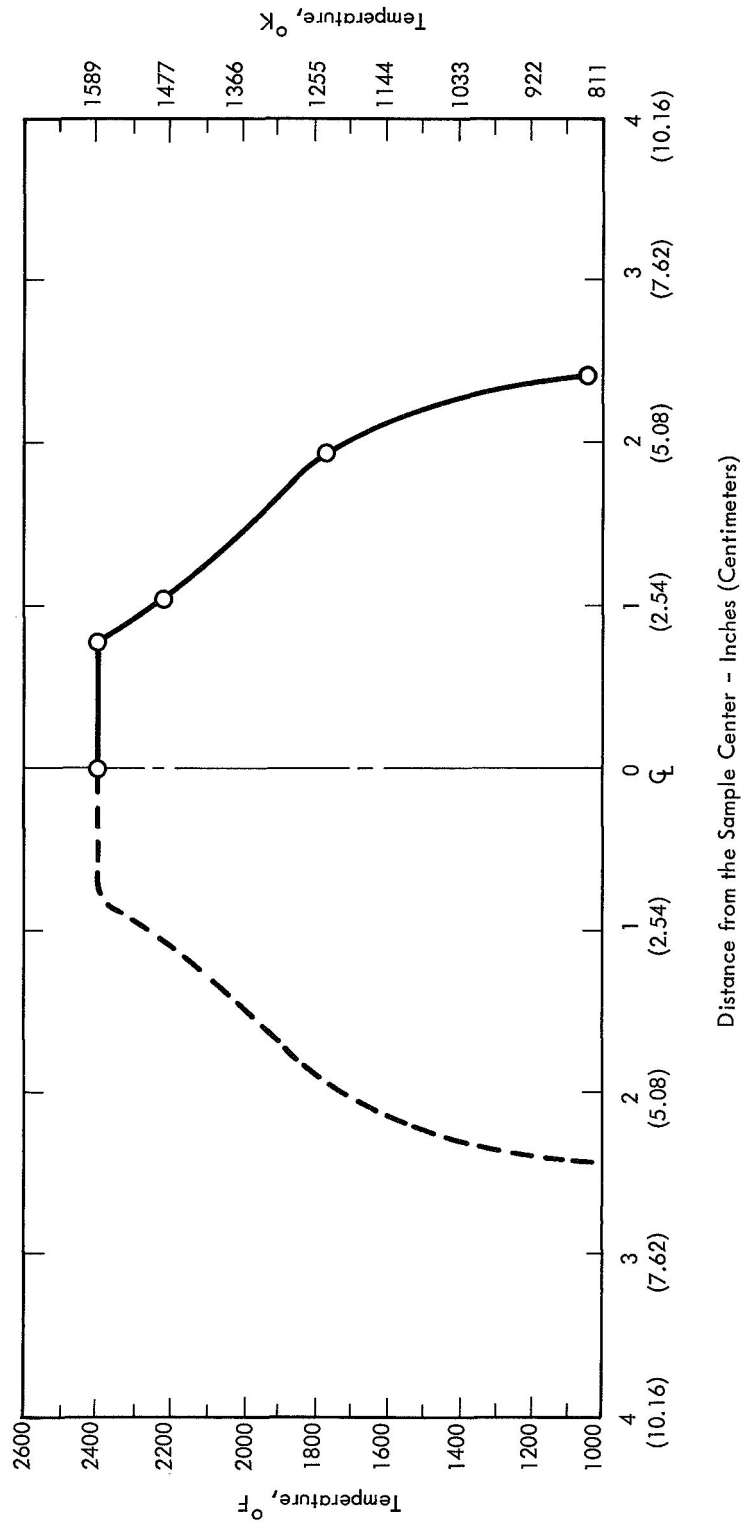
FIGURE 18 - Appearance and Temperature Profile of Creep Sample 27

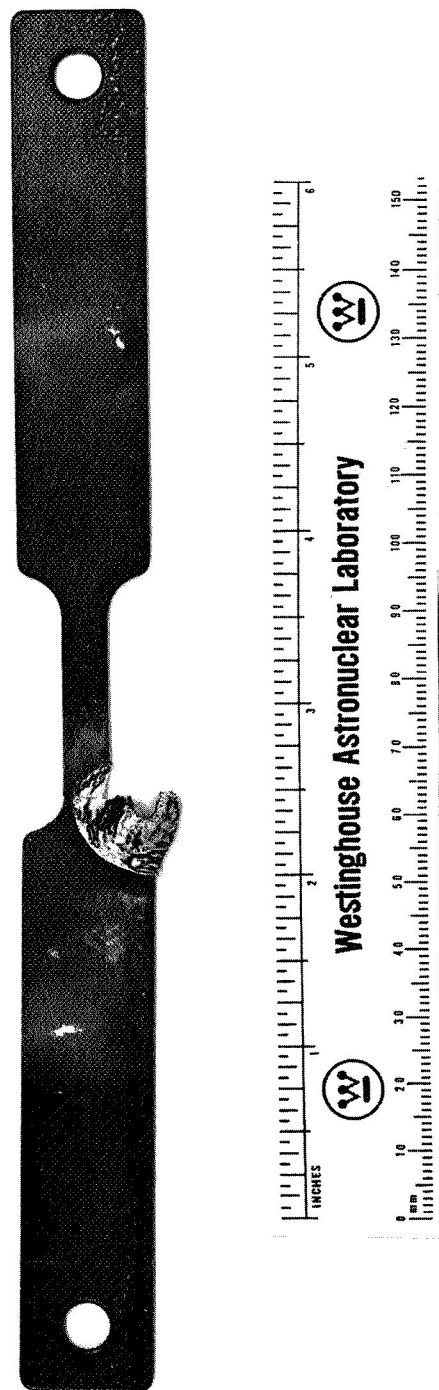
FIGURE 19 - Appearance of Creep Sample 15

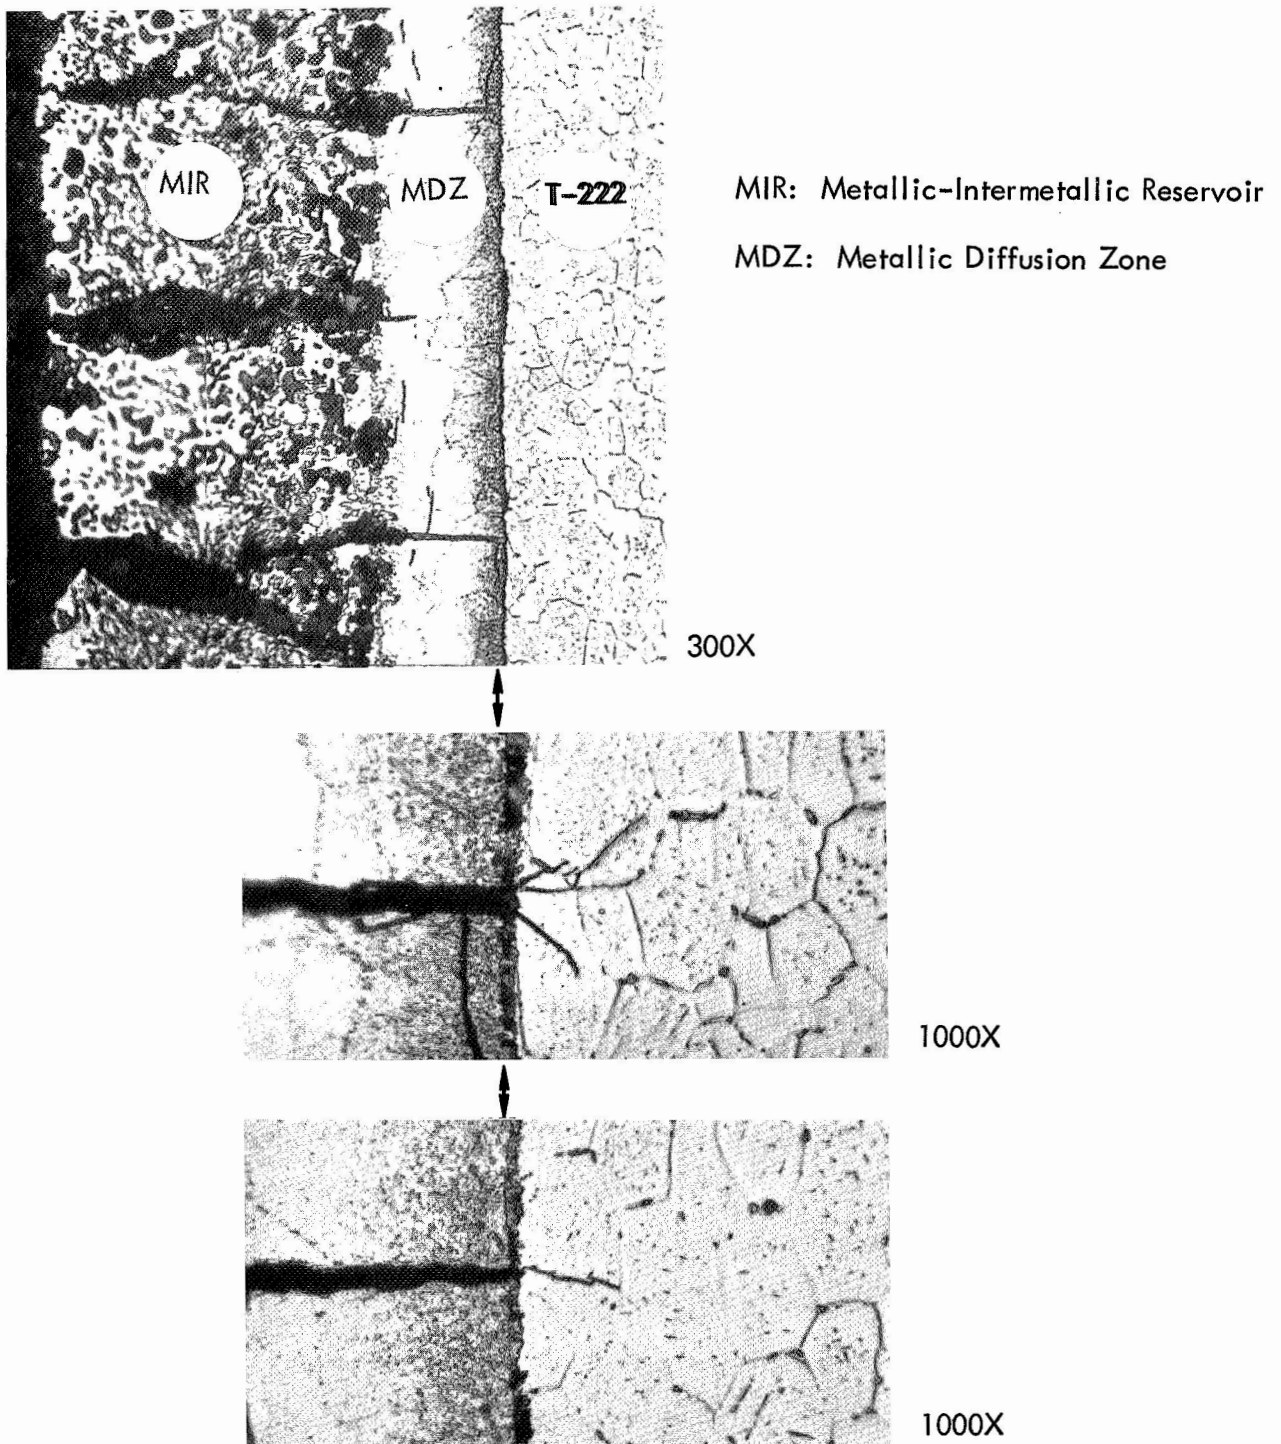
FIGURE 24 - Oxide Formation on Creep Sample 27

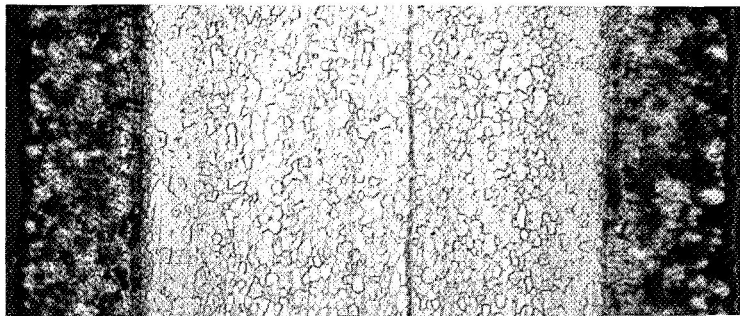
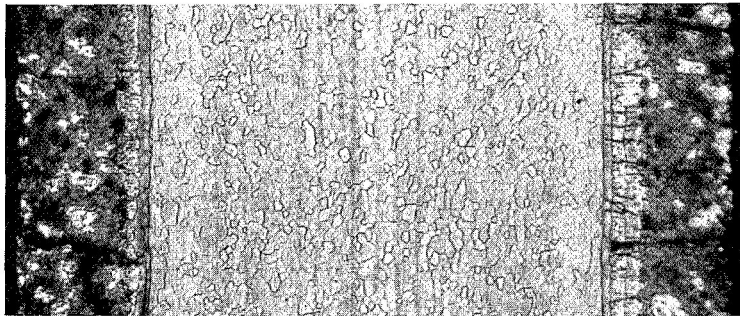
<u>Condition</u>	<u>Substrate Thickness</u>	
	<u>Original</u>	<u>Final</u>
As-Coated	0.0309"	0.0301"

Coated +		
10 Hrs/2400°F	0.0313"	0.0292"

FIGURE 33 – Substrate Recession Due to Coating and Oxidation at 2400°F
Mag: 80X 0.001" = 0.025 mm

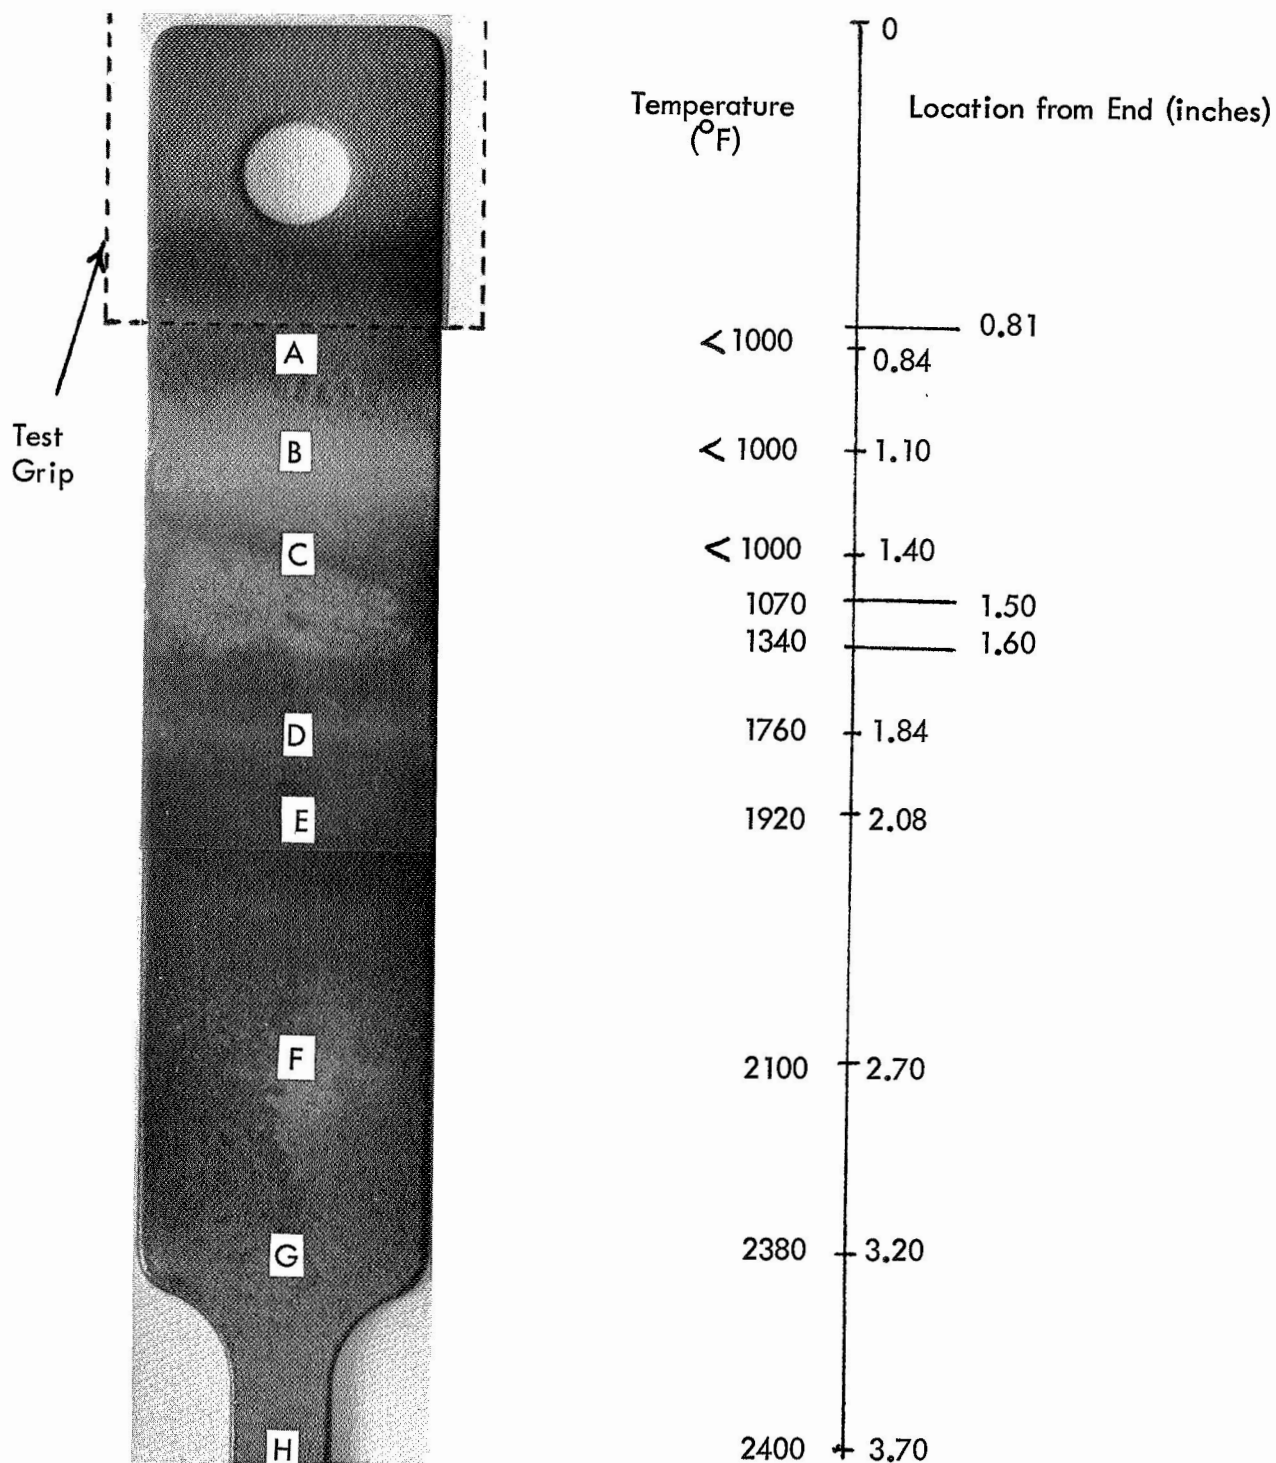
FIGURE 39 - Temperature Distribution and Surface Appearance Along Creep Sample 38. Air Test 500 Hours/2400°F

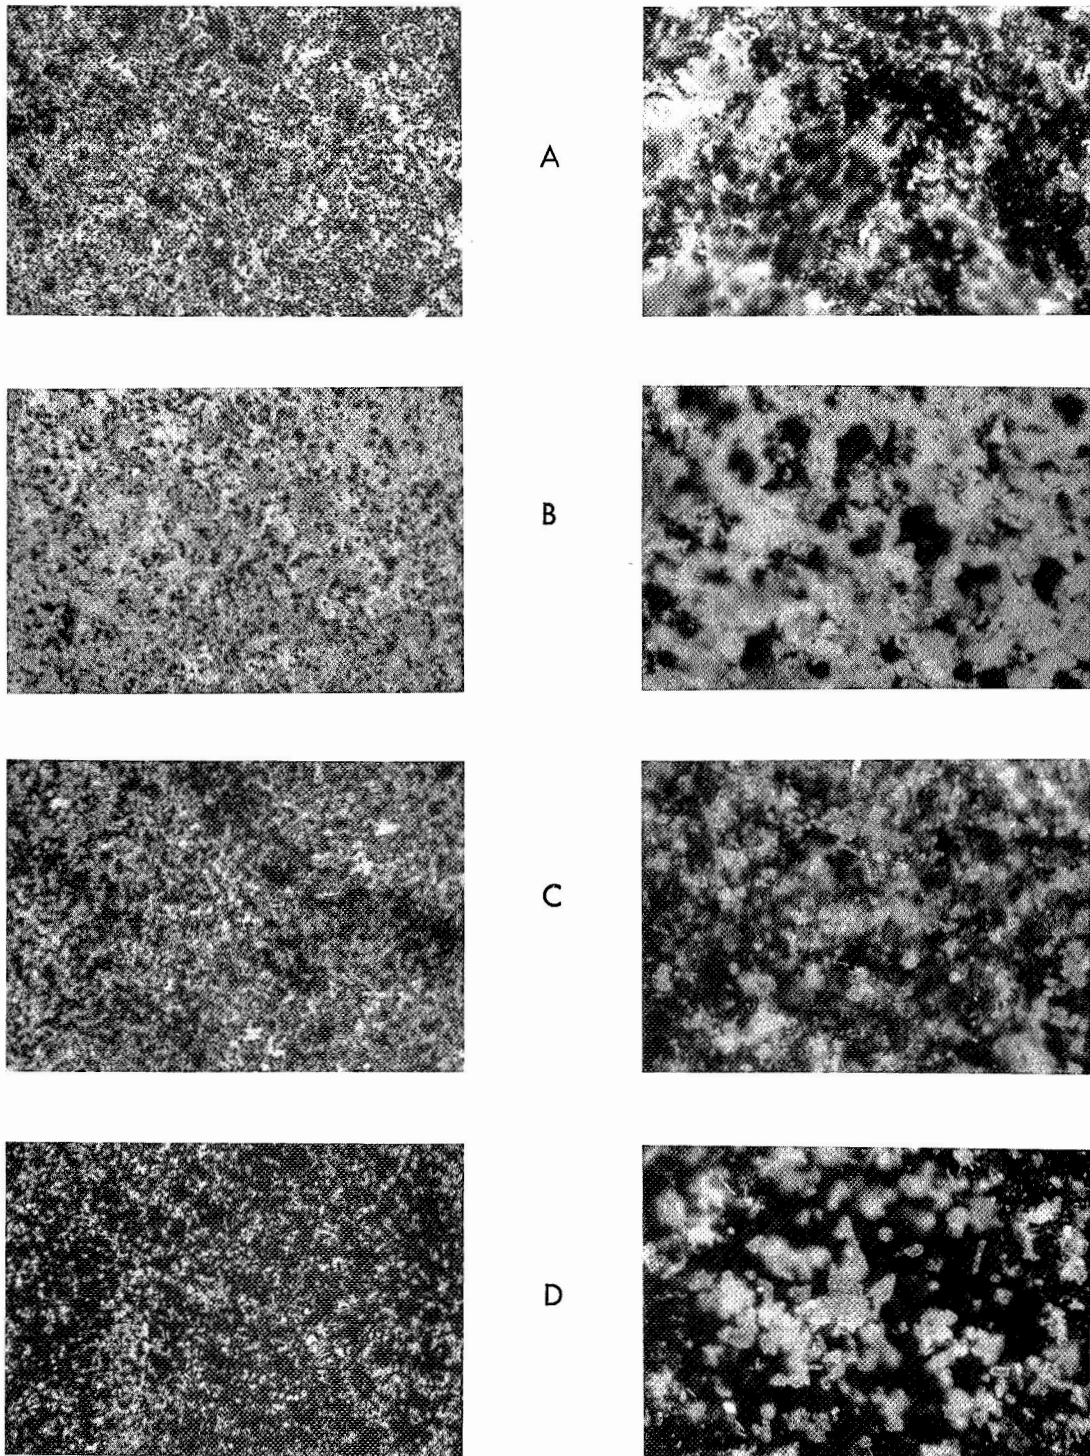
Microstructures observed on the coating surface at several of the positions identified in Figure 39 are displayed in Figure 40. Structure could not be clearly defined at positions where a powder-like surface was present — positions A through C. Note that although the coating region at position C appears crazed (see Figure 39), the 50X picture of this region presented in Figure 40 revealing two craze marks, shows them as dark lines rather than cracks. Closer examination of these marks confirmed that they were not associated with cracks.

FIGURE 40 - Structure of the Coating Surface on Sample 38.
A-D: Positions Identified in Figure 39.
Left: 50X Polarized Light Illumination
Right: 200X Polarized Light Illumination
